RANDOM GLASS EXPLOSIONS

PANE IN THE GLASS

Nickel sulphide failures in glass are the cause of random glass explosions around the country. **Simeon Barut** investigates the best way to minimise future incidents.

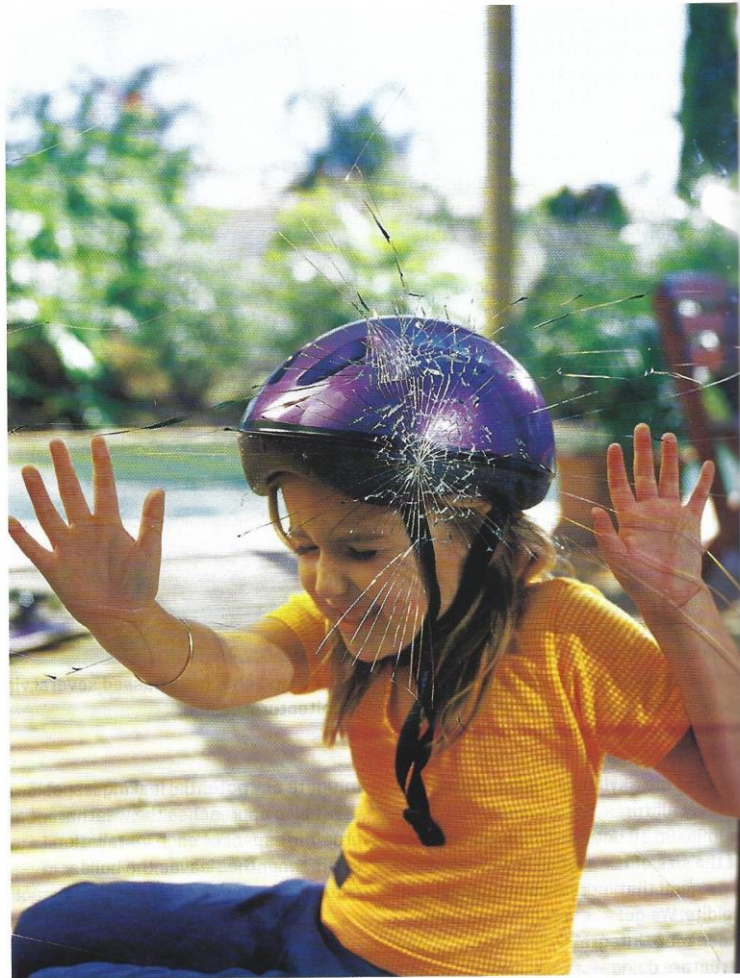
Safety film helps hold glass together in the event of breakage.

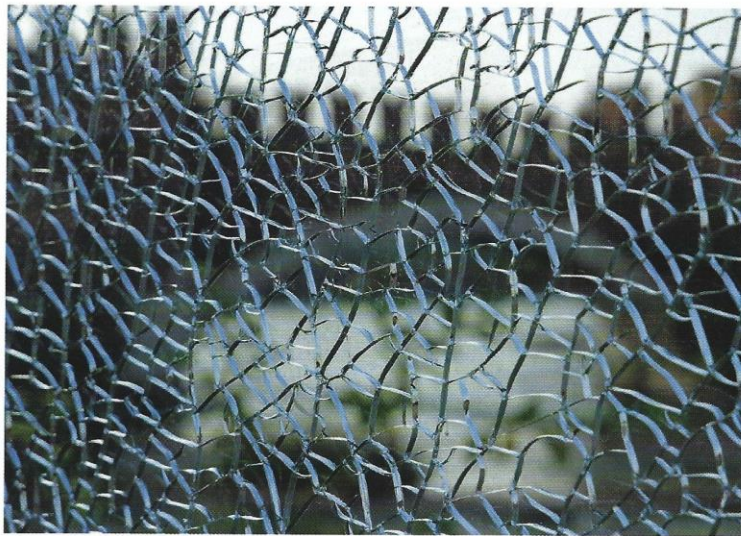
Toughened glass is meant to segment into small pieces when broken

"The revision of AS2208 has been in the works for 10 years and this is because the current specs needed to classify as 'toughened glass' aren't stringent enough. Toughened glass should break into small little particles minimising harm to anyone near it but in some cases, it can clump together in large chunks and/or form longer sharp splines which can do some serious damage - hence the reason for a revision," says Rob.
